**PM STRAUSS & ASSOCIATES**  
**ENERGY AND ENVIRONMENTAL CONSULTING**

**MEMORANDUM**

**TO:** CPEO  
**FROM:** Peter Strauss  
**DATE:** March 22, 2017  
**SUBJ:** **Hangars 1, 2, and 3 at Moffett Field**

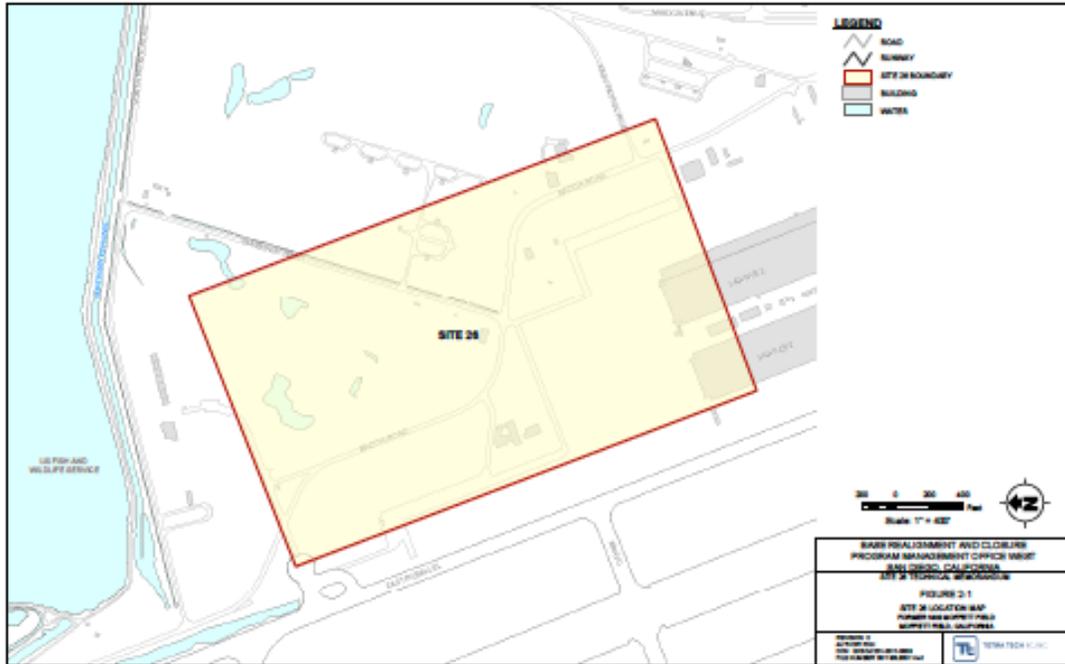
The 1996 OU5 Record of Decision (ROD) selected remedies for the chlorinated volatile organic compounds (CVOCs) in groundwater on the east side of Moffett (Site 26). The Site 26 CVOC groundwater plume begins at the northeastern corner of Hangar 3 and migrates northward, away from the two hangars. Some of the CVOCs released into groundwater from the Site 7 are addressed as part of the remedy for Site 26.

**Hangars 2 and 3 are shown on the right (southern) edge of Site 26.**
